SPALLING OF TUFFEAU LIMESTONE: STATISTICAL ANALYSIS OF SAMPLES FROM THE CASTLE OF CHAUMONT-SUR-LOIRE, FRANCE

Context

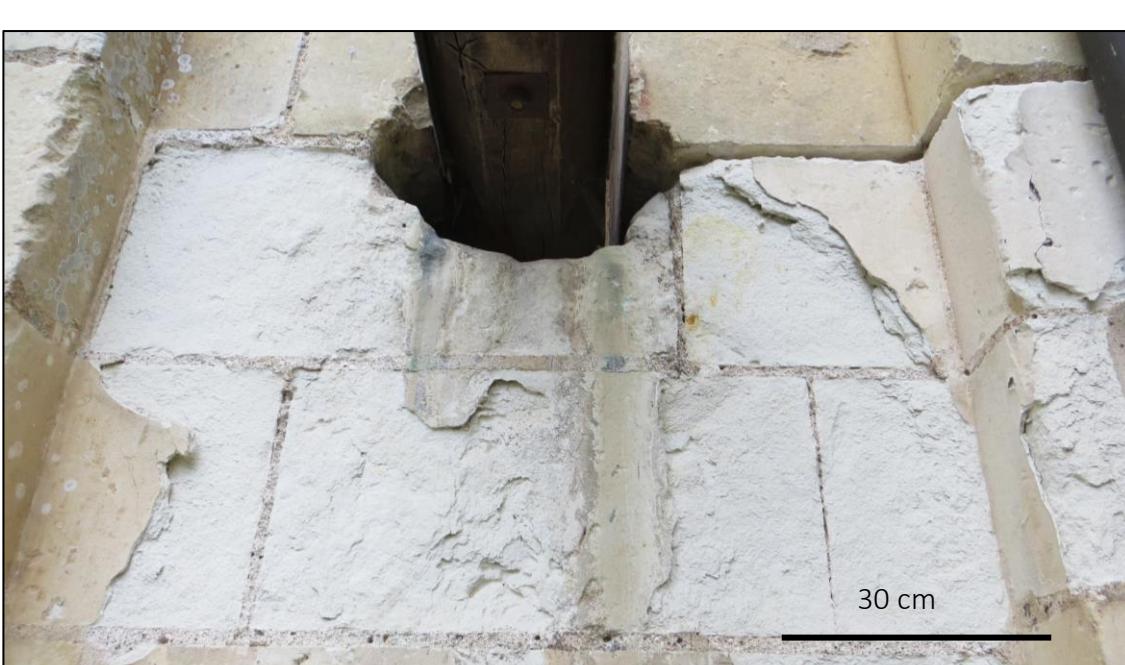
Example of spalling on tuffeau stone

Tuffeau stone is the typical building stone of the famous castles of the Loire Valley, as the castle of Chambord or castle of Chaumont-sur-Loire. Tuffeau is a soft and white fine-grained sedimentary limestone, containing calcite, quartz, opal, micas and clay minerals, with high porosity about 45% and a low strength about 5-10 MPa. Spalling is a major degradation of tuffeau that involves the progressive cracking inside the stone and progressive separation of a plate of stone, parallel to the surface exposed to the environment. The morphology of the spalling observed in the constructions in tuffeau in the Loire Valley is generally the same, even if the thickness of the plate can vary from a few millimetres to a few centimetres. The mechanisms of formation of spalling in case of tuffeau are not well defined.

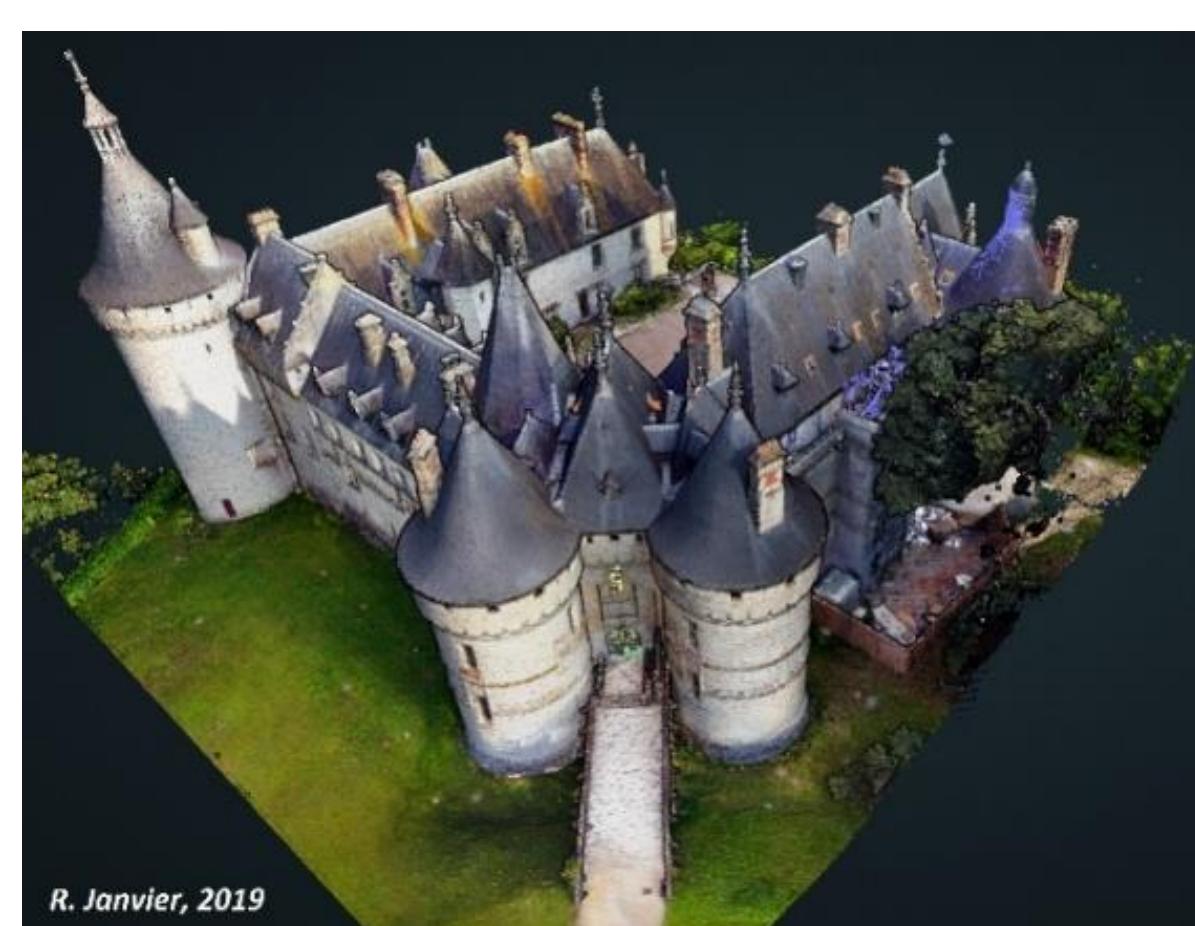
3D model in point cloud of the castle of Chaumont-sur-Loire

Overview of the castle

The 3D survey consisted in a photogrammetric acquisition with images taken by a 20 Mpx camera aboard a drone DJI Mavic pro 2. About 4500 photos are used in the photogrammetric process for 3D reconstruction for the exteriors of the castle of Chaumont-sur-Loire. This dataset was processed using the photogrammetry software Reality Capture. For the mapping, the numbering of the facades was done with the following procedure: the numbering begins with the facade of the main entrance door (facade No. 1), and then the numbering progresses clockwise from the top view. Round towers generate one façade but several orientations.

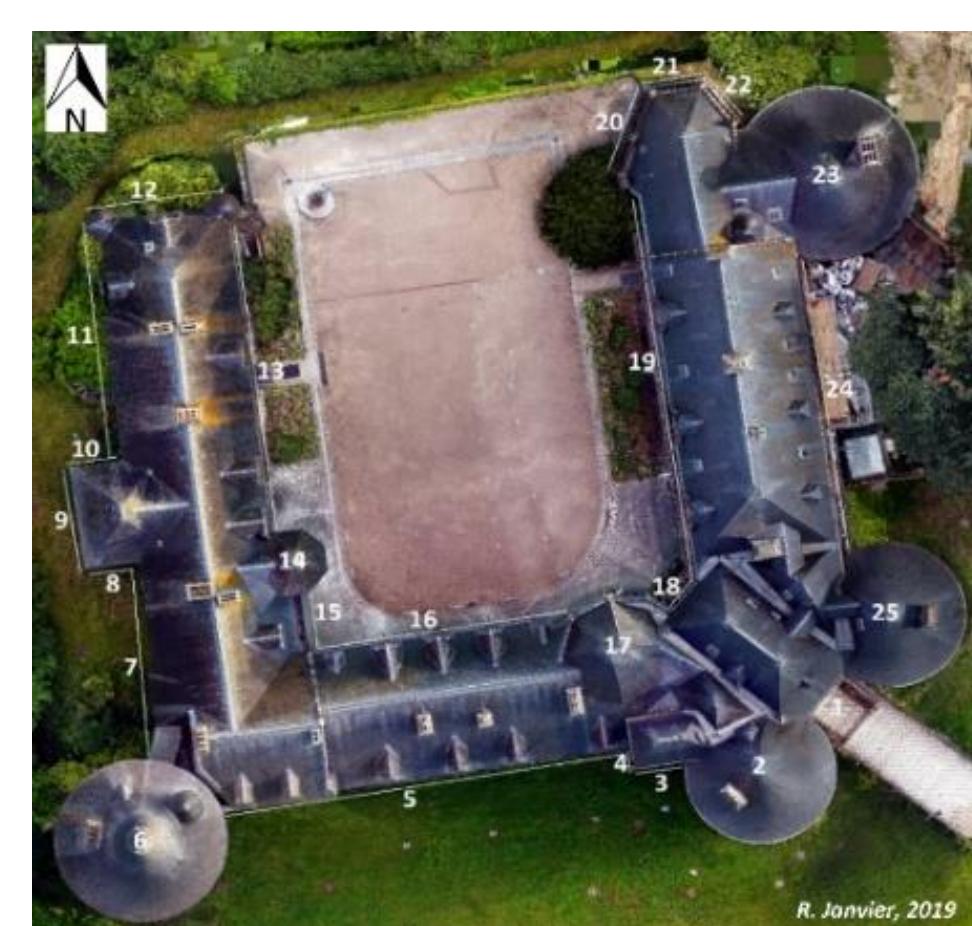
Top view of the 3D model showing the numbering of the facades

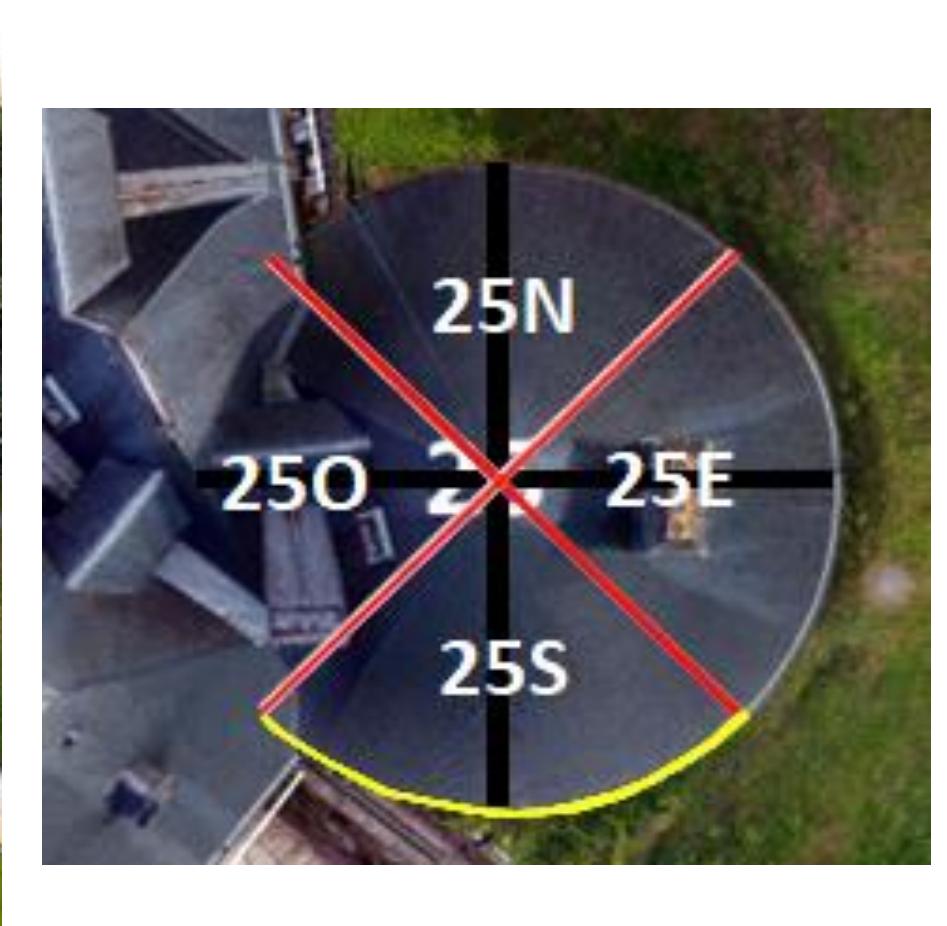
Delimitation of orientations for the round towers

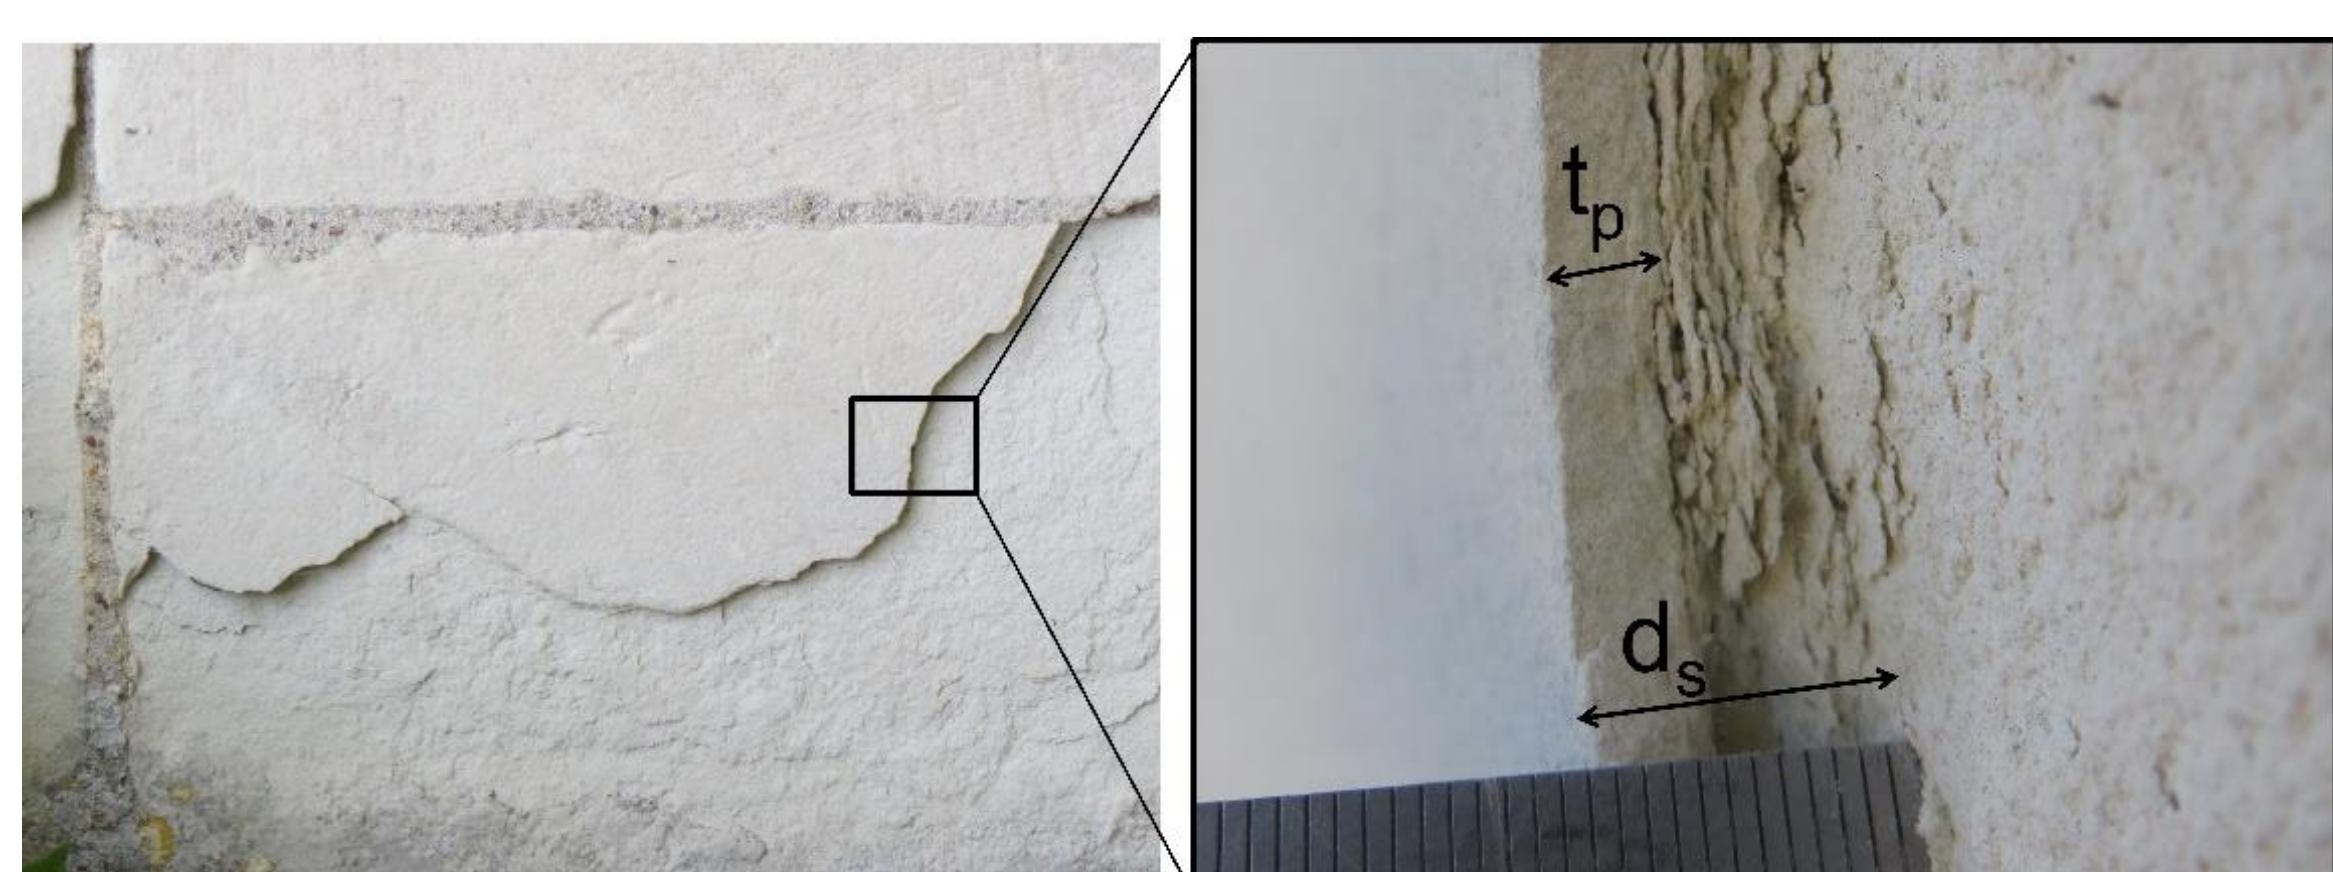
Example of spalling on the stone from the castle of Chaumont-sur-Loire with a view of the thickness of the plate t_p and the total depth of spalling d_s

An amount of 75 samples were collected in the most representative degraded stone of each area. For each area, the number of stones degraded by spalling is recorded, as well as the thickness of the plate and the total depth of spalling. The mineralogical characterization of samples was performed by X-ray powder diffraction (XRD). The soluble compounds were quantified via aqueous phase ionic chromatography, and sulfate SO_4^{2-} anions to determine gypsum content.

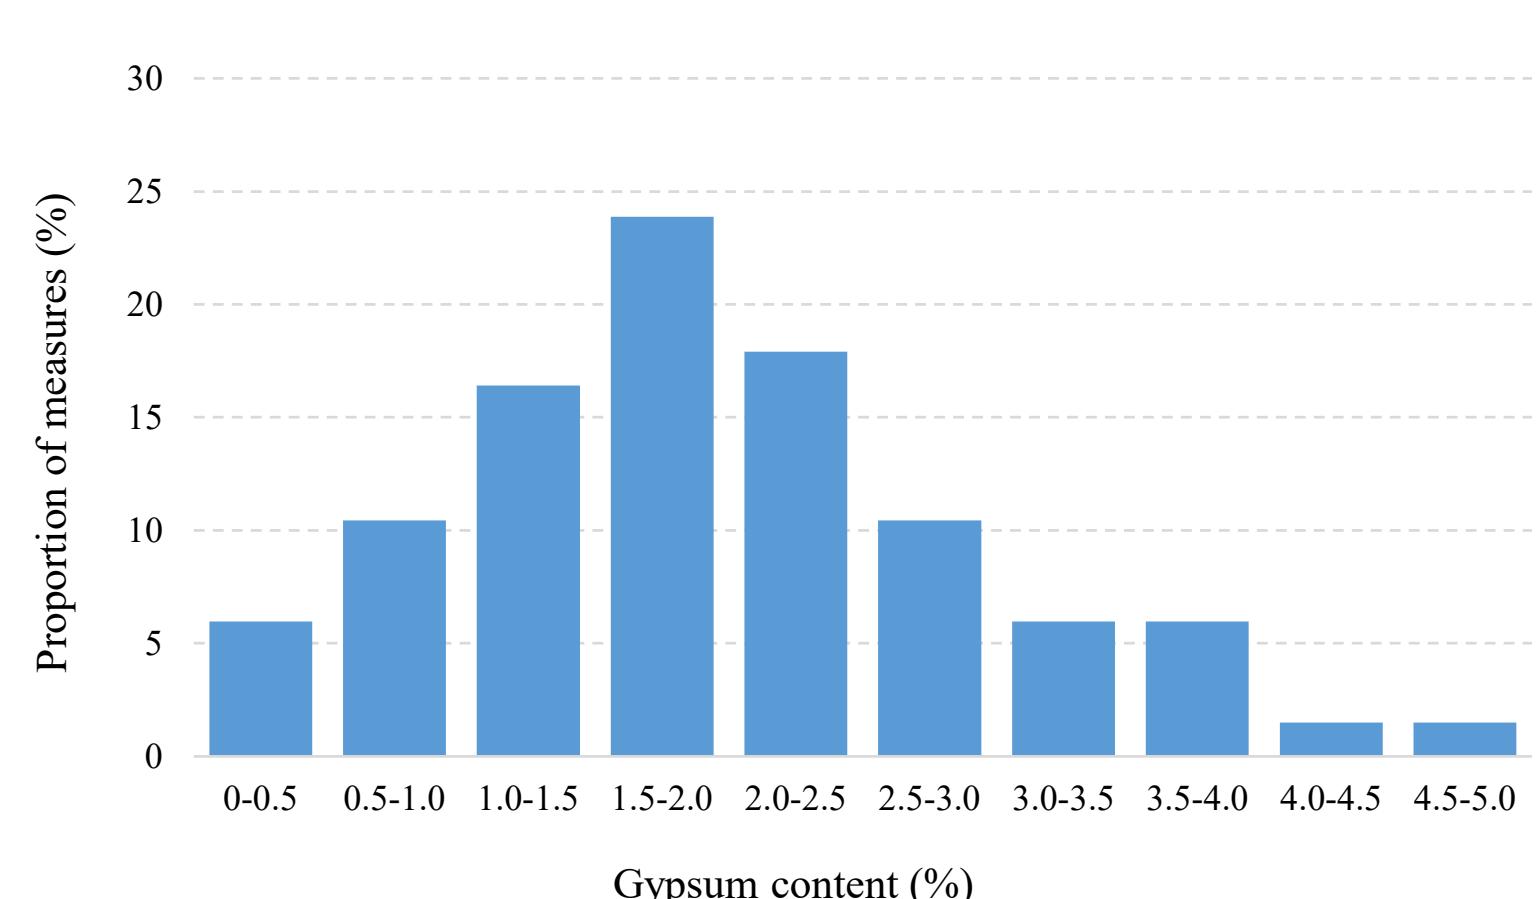
thickness of the plate “ t_p ” (mm)	depth of spalling “ d_s ” (mm)	number of stones degraded per area	Gypsum content (%)
Average (± standard deviation)	3.9 (± 1.3)	10.2 (± 5.5)	5.1 (± 4.8)	1.9 (± 0.9)
Minimum value	2.0	4.0	1	0.2
Maximum value	8.0	32.0	26	4.8

Statistics of spalling morphology of tuffeau (castle of Chaumont-sur-Loire)

The thickness of the plate t_p is nearly constant with an average value of 3.9 mm. The total depth of spalling d_s is quite dispersive with an average value of 10 mm. The gypsum content has an average value of 1.9% where almost 40% of gypsum content are between 1% and 2%. Spalling can affect only a single stone as well as a continuous set of several stones

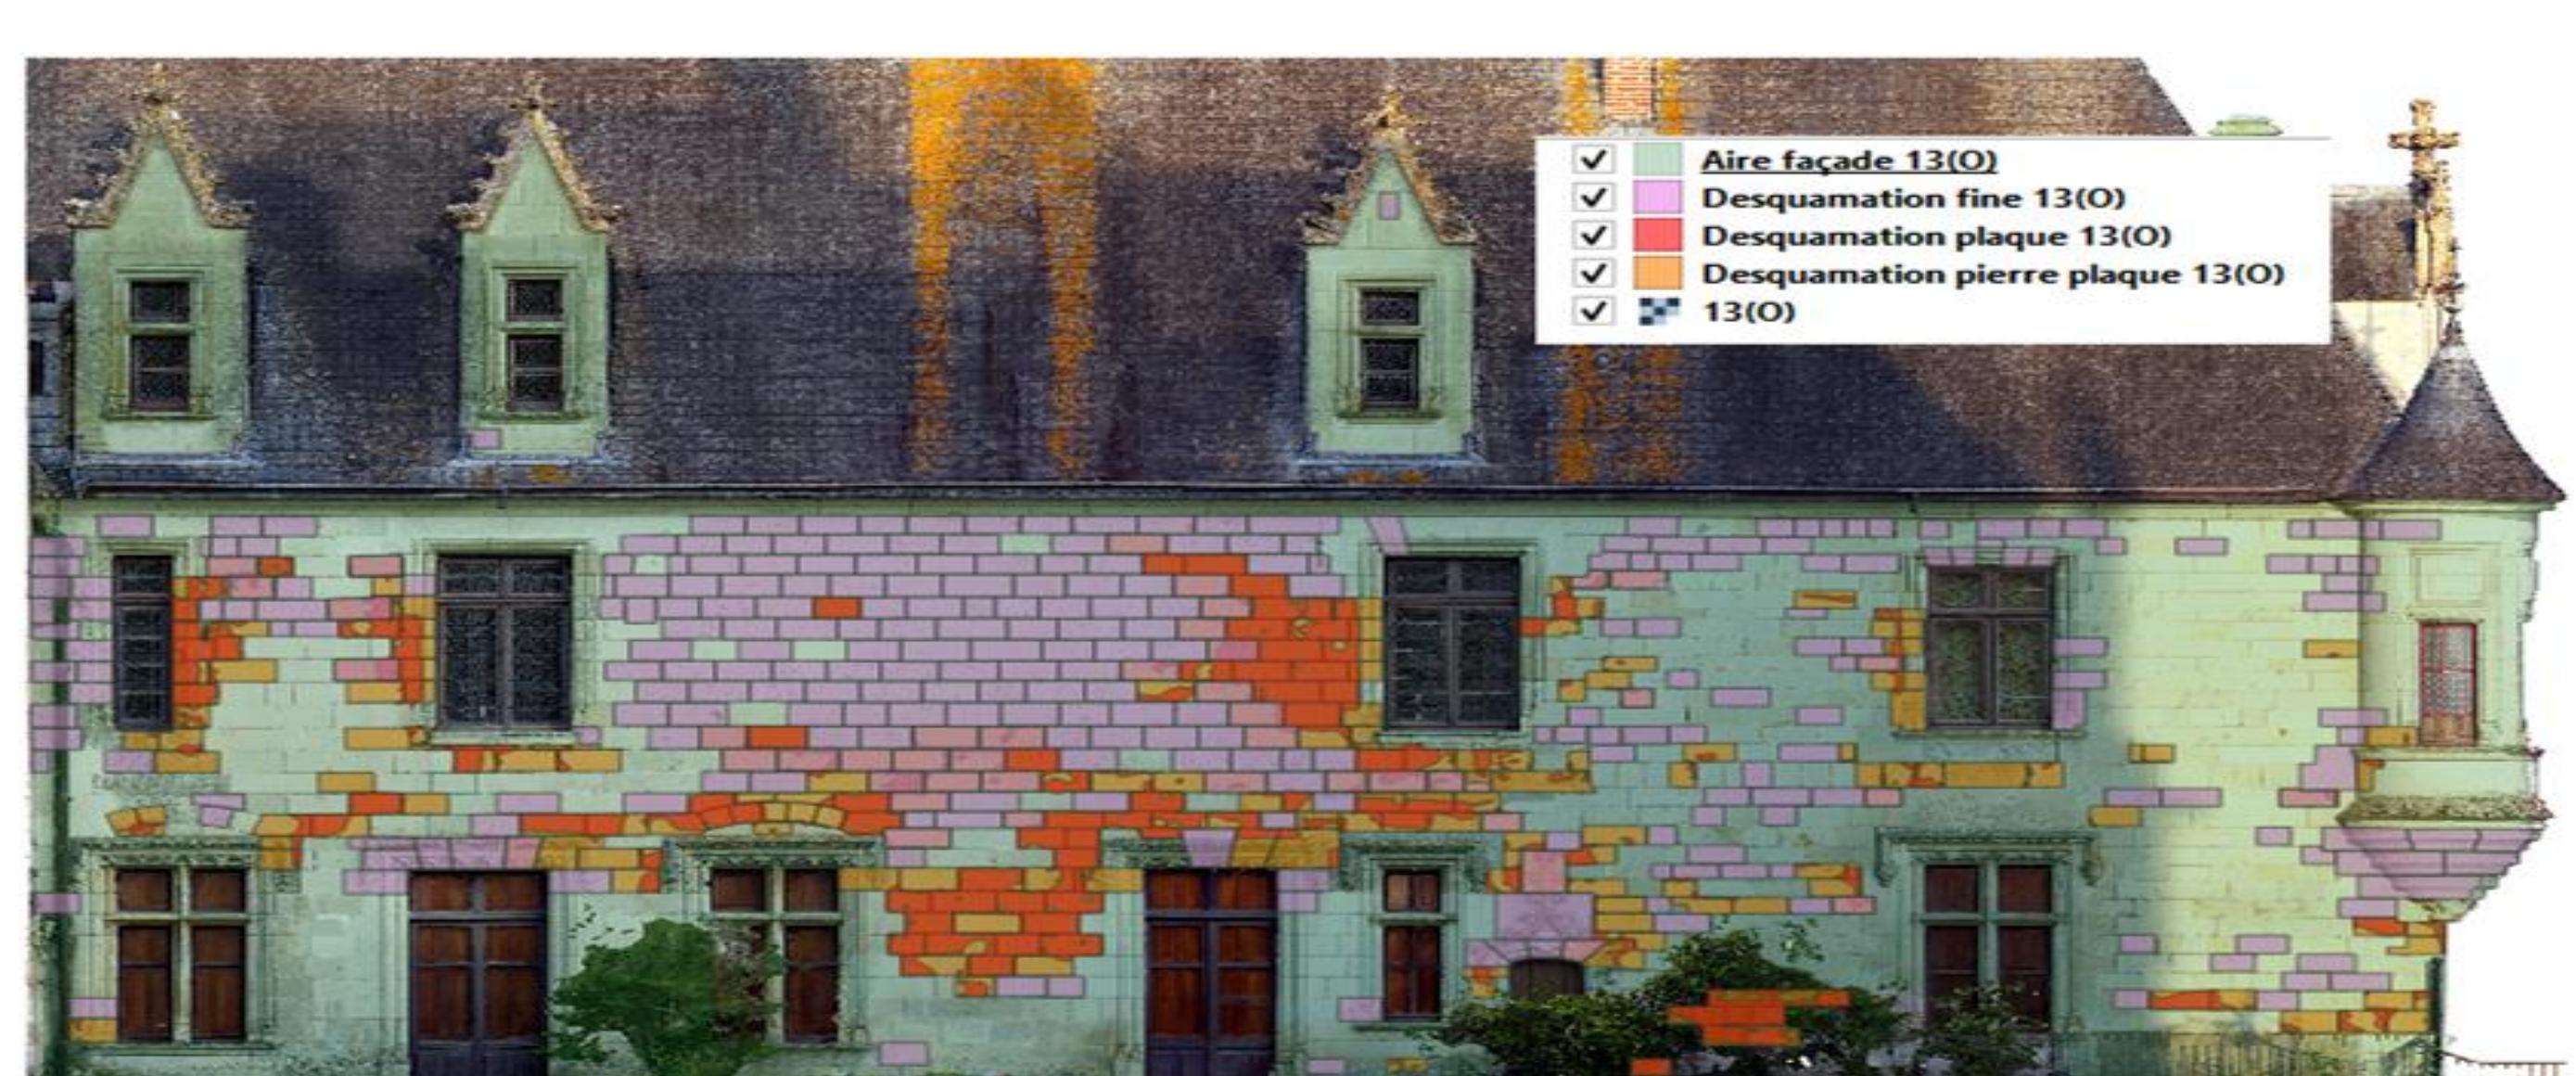
Orthoprojection of the façade No. 13 with degradation mapping (QGIS)

From the 3D model, 34 maps resulting from ortho-projection of the oriented wall was established for degradation patterns made with QGIS, open-source software. The various layers represent the total surface area of the stone masonry, the total surface area of the degraded stones showing spalling.

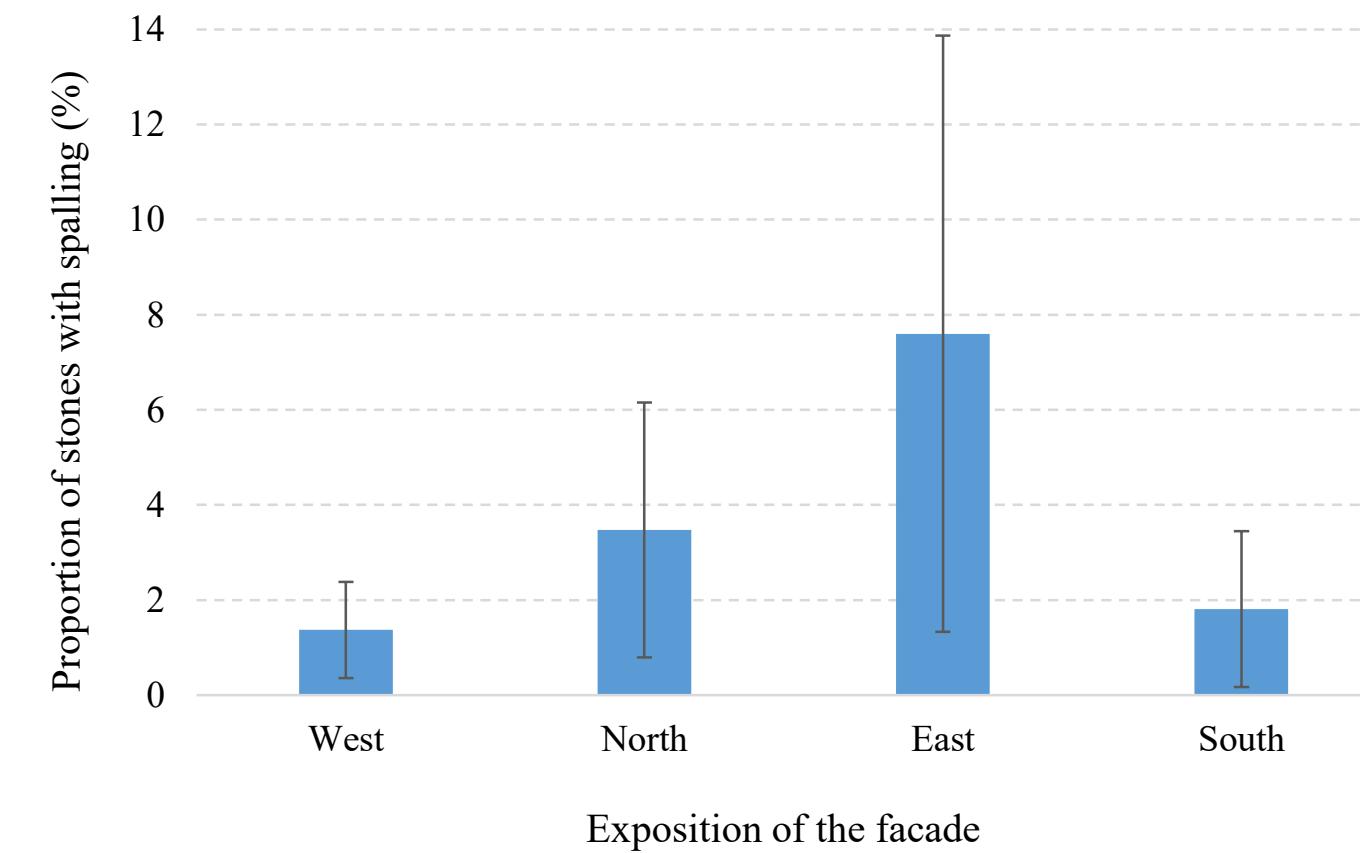
Proportion of stones with spalling according to the exposition of the façade from QGIS measurement

A total of 917 degraded stones by spalling were counted for all the facades. No significant difference between the spalling morphology is observed according to the orientations, as well as the gypsum content. More spalling was observed in the degraded areas facing east. But observation of the castle shows that the eastern facades are the least restored.
